REPORT OF RCRA COMPLIANCE EVALUATION INSPECTION

Chrome Reflections
4141 East 14th Street
Des Moines, Iowa 50313
(515) 491-8915
EPA ID Number: IAR000521112

April 15, 2019

U.S. ENVIRONMENTAL PROTECTION AGENCY
Region 7
Enforcement & Compliance Assurance Division

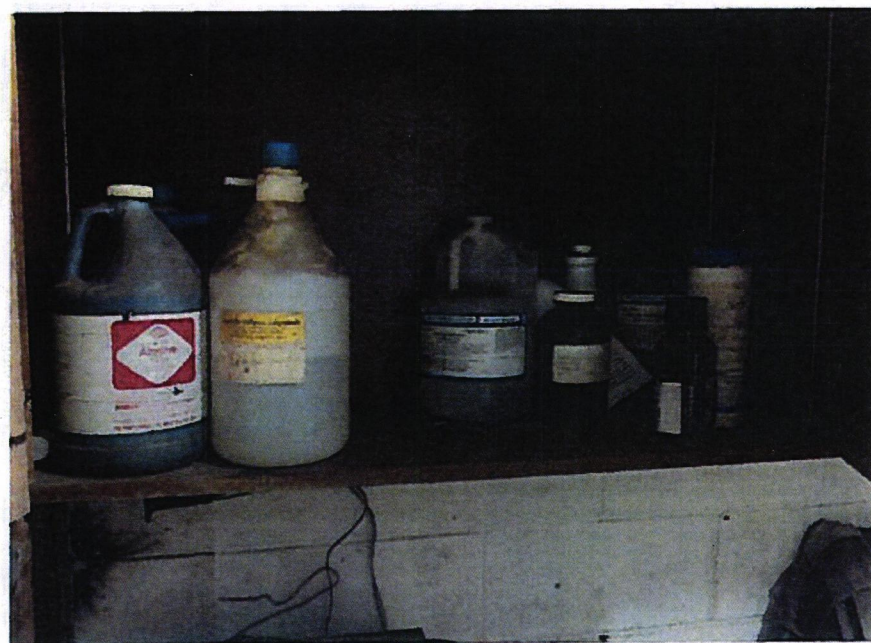
Photo 4 – 9/6/2016. Chemicals located in the north storage rooms

Chemicals in North Storage Rooms - I observed approximately 25 containers of chemicals in two cabinets located in the north storage room that may have been used as part the conditioning/treatment system for make-up water for the plating operation that were identified during the September 9, 2016, EPA inspection and included on the 2016 NOV for failure to make a waste determination (photos 3 & 4 in attachment 7). The chemicals remain onsite and the conditions appeared to be unchanged since the September 9, 2016, EPA inspection. I informed Ms. Atkinson that a waste determination must be performed to ensure proper disposal (attachment 9).

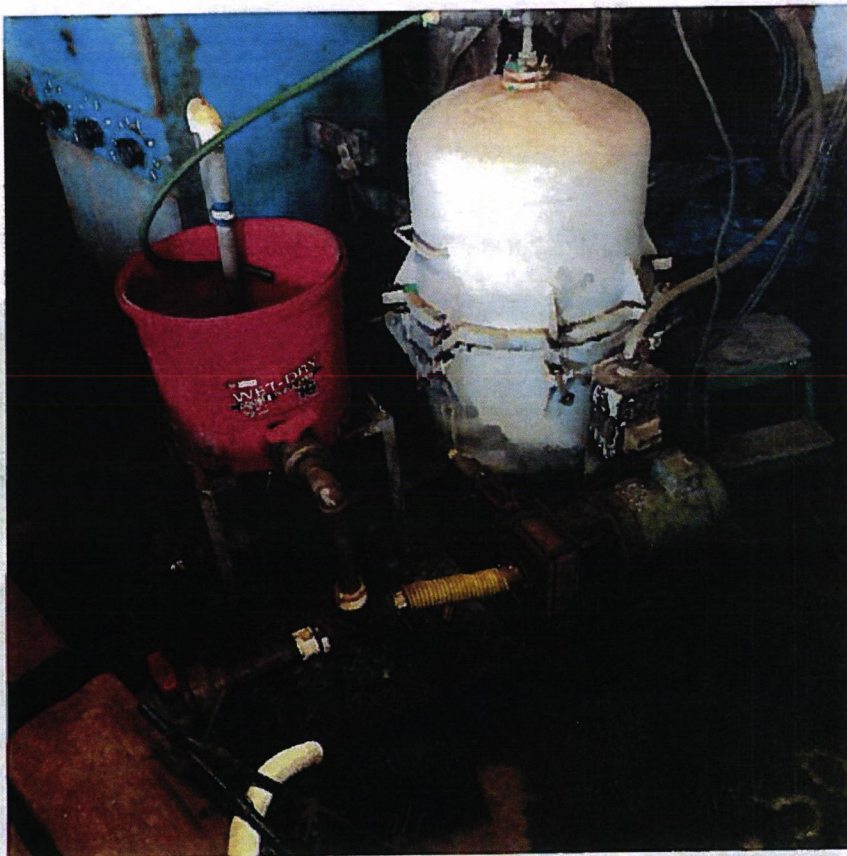
Photo 5 – 9/6/2016, Reactor tank and residue on the concrete floor.

Reactor Tank North of Plating Line - I observed chemical reactor tank and piping utilized to mix plating solutions prior to being used in the plating tanks located directly north of the plating tank 8 that was identified during the September 9, 2016, EPA inspection and was included on the 2016 NOV for failure to make a waste determination (photo 5 in attachment 7 and photo 19 in attachment 5). The reactor tank appeared to be unchanged since the September 9, 2016, EPA inspection. I informed Ms. Atkinson that the residue would need to be cleaned out of the reactor tank and piping and a waste determination must be performed to ensure proper disposal (attachment 9).

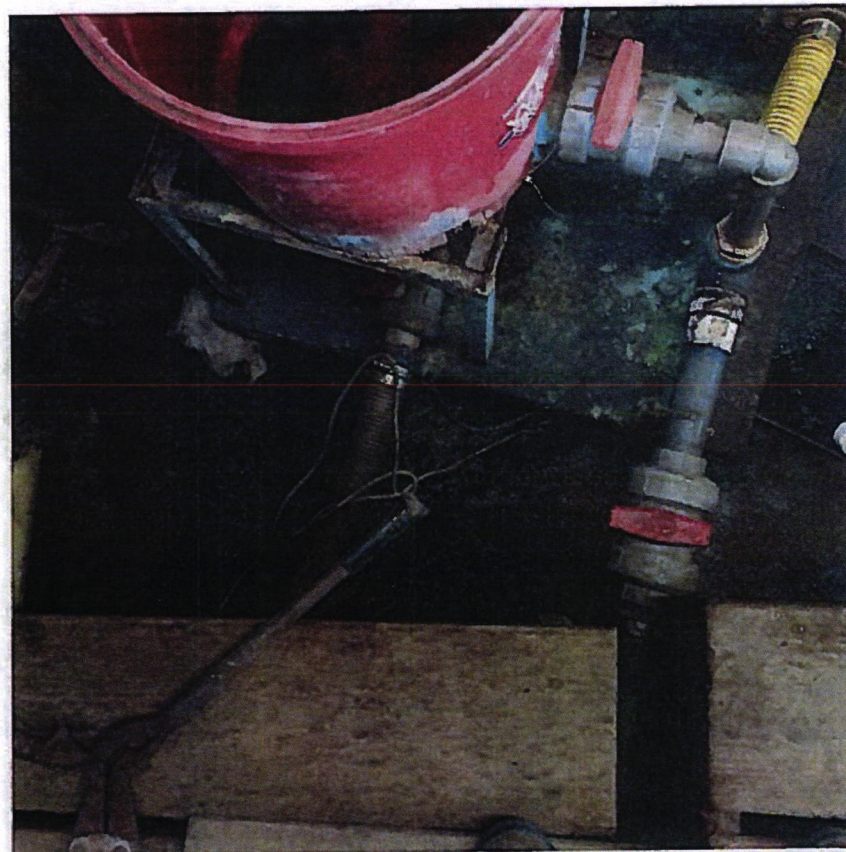
Photo 6 – 9/6/2016. Residue on the concrete floor.

Residue on Floor of Plating Room - I observed residue on the floor throughout the plating area and at the east end of the facility that was identified during the September 9, 2016, EPA inspection and was included on the 2016 NOV for failure to make a waste determination (photos 5 & 6 in attachment 7). The residue remains on the floor and the conditions appeared to be unchanged since the September 9, 2016, EPA inspection. I informed Ms. Atkinson that the residue would need to be cleaned up from the plating room floor and a waste determination must be performed to ensure proper disposal (attachment 9).

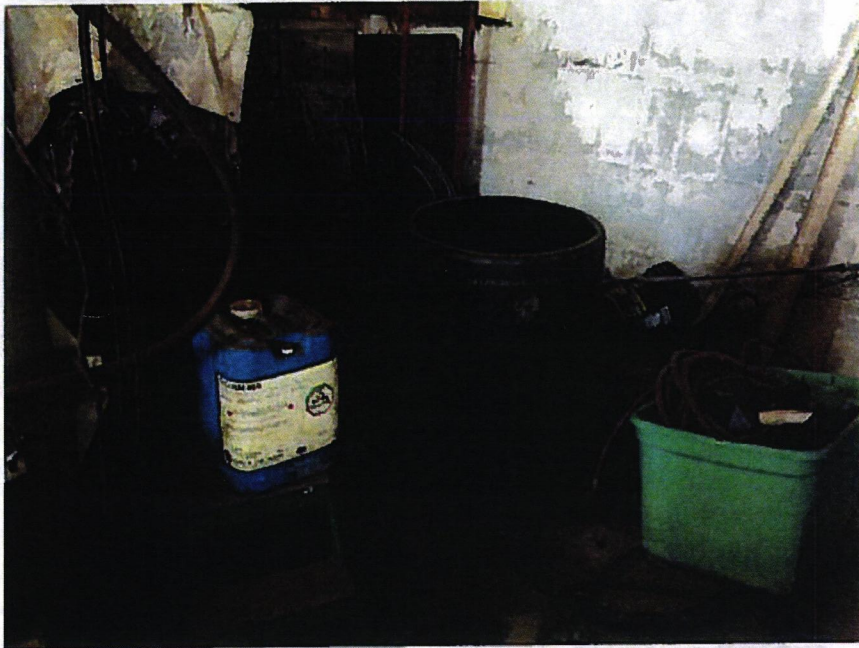
Photo 7 – 9/6/2016. Black open top 55-gallon container that was approximately 1/6 full and five-gallon carboy containing approximately one gallon of liquid.

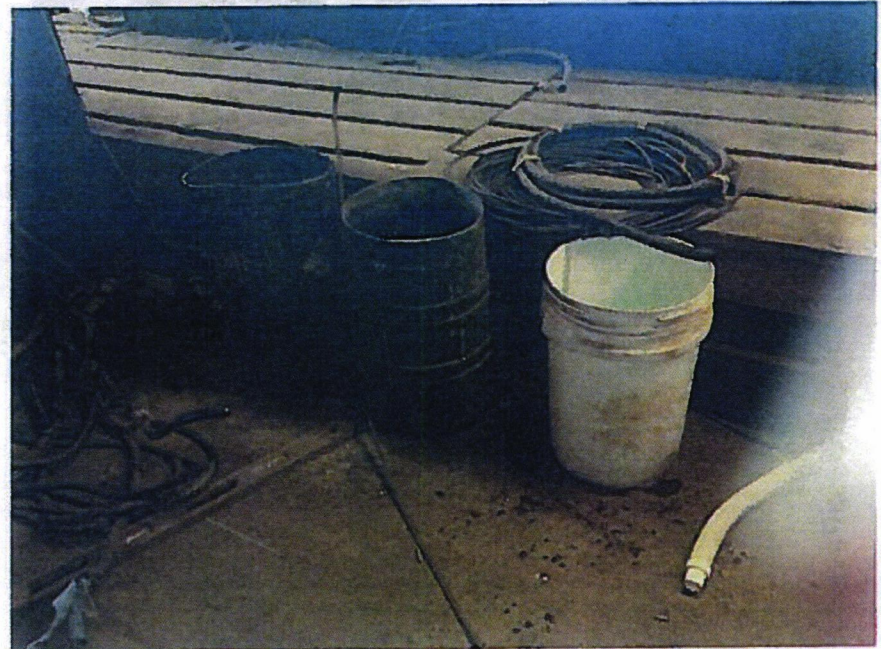
Photo 8 – 9/6/2016. Three open top 15-gallon containers. Containers from left to right are holding 10 gallons, five gallons, and 10 gallons respectively.

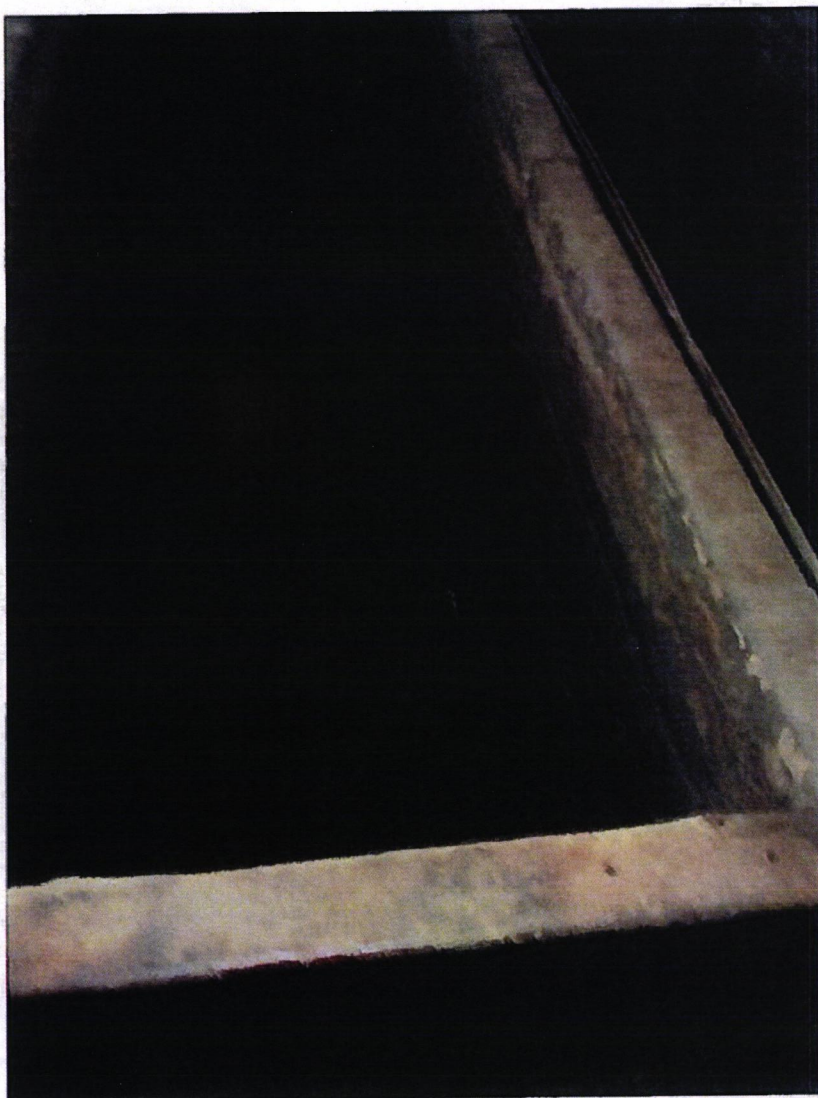
Photo 9 – 09/06/2016. Leftover liquids and sludge in a main plating line tank.

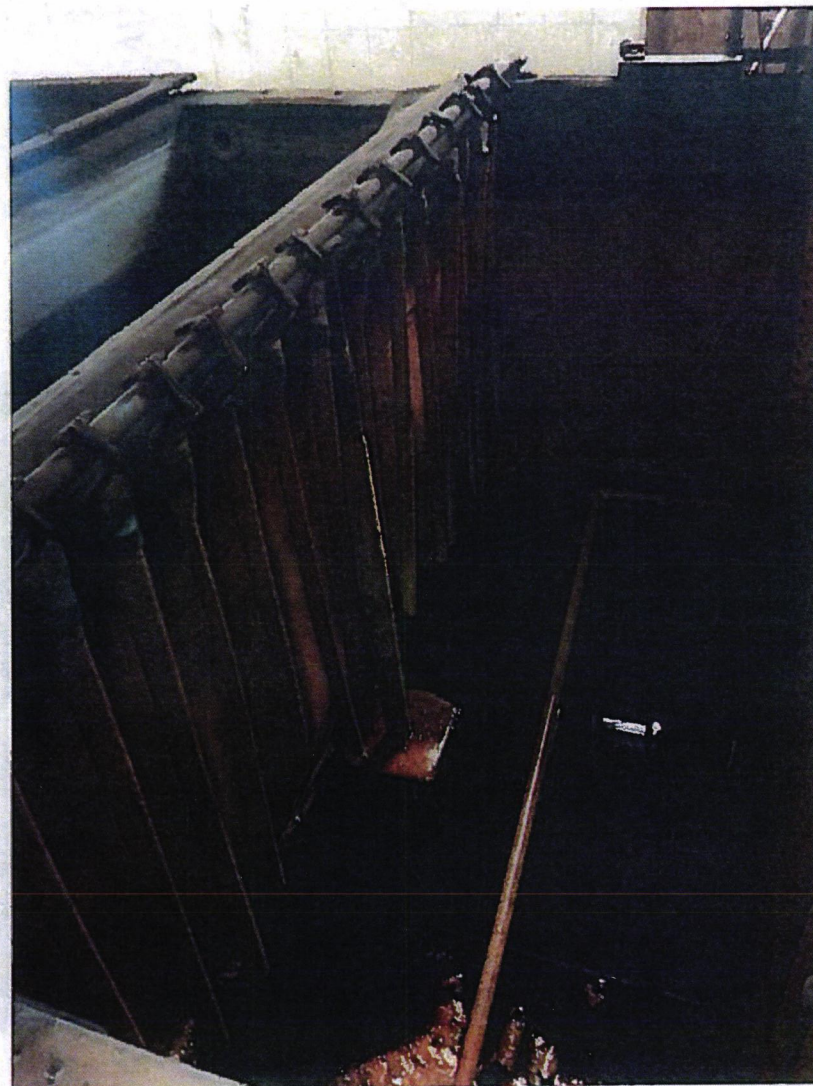
Photo 10 – 09/06/2016. Leftover liquids and sludge observed in a main plating line tank. Lead anodes hanging from a steel bar on the left side of the tank.

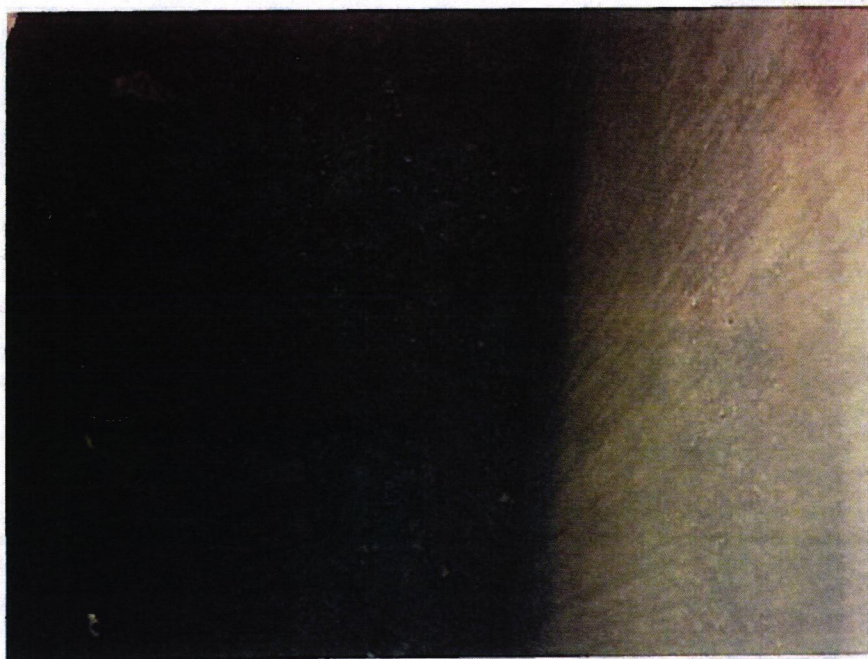
Photo 11 – 09/06/2016. Sludge and debris observed inside of a main plating line tank.

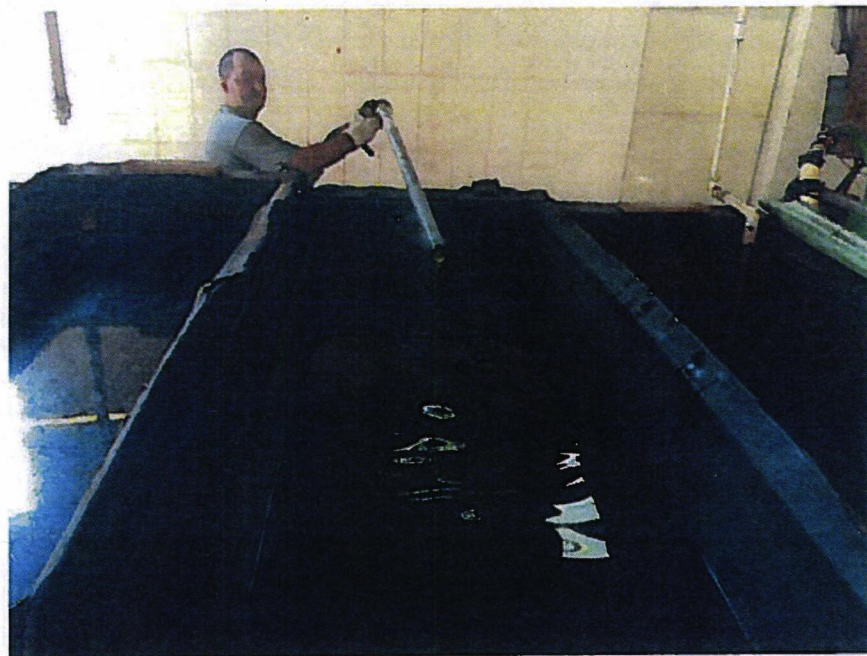
Photo 12 – 09/06/2016. Liquid being removed from plating tank by the waste hauler. Waste hauler reported that the aluminum "stinger" used was reacting with the plating solution and becoming "etched" (see smoke emanating from the stinger).

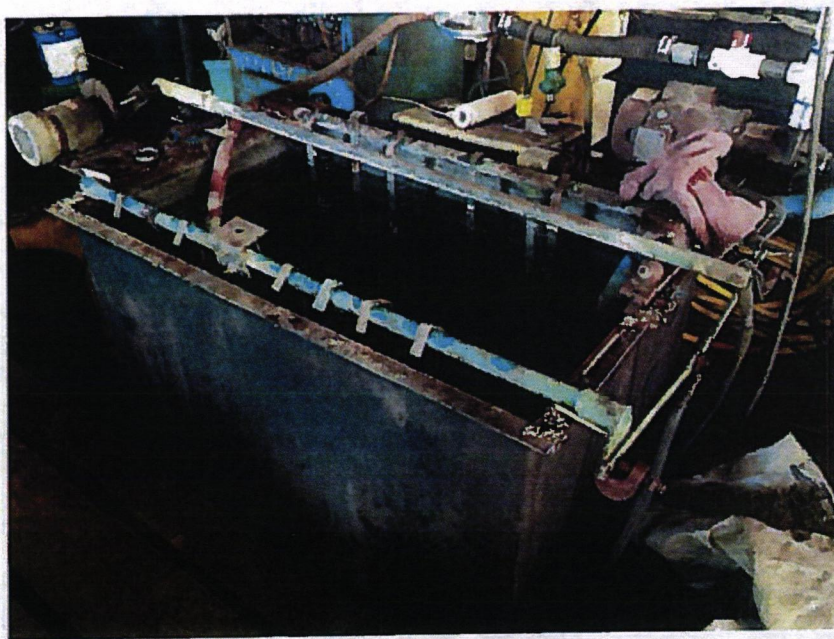
Photo 13 – 09/06/2016. Plating tank north of the main plating line.
Lead anodes hanging from the steel piping on the sides of the tank.

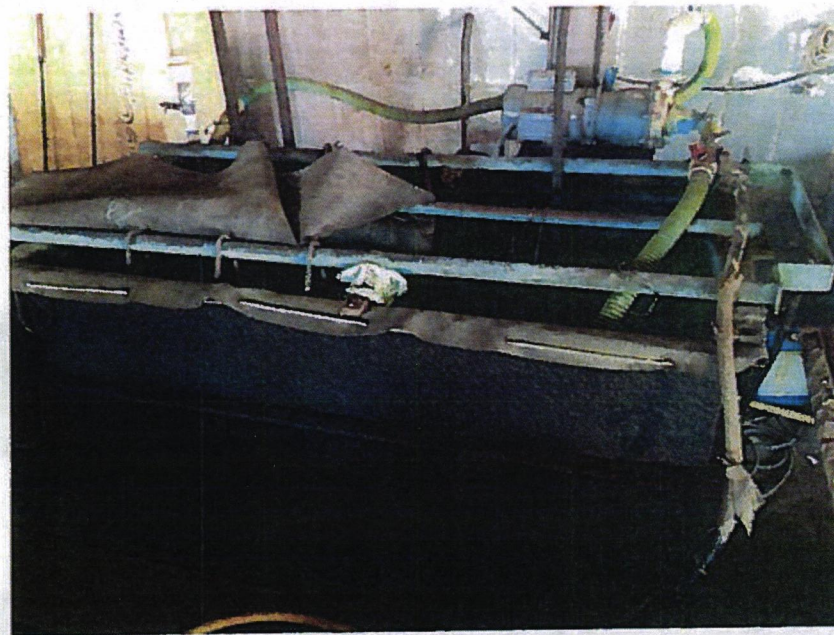
Photo 14 – 09/06/2016. Plating tank north of the main plating line.
Lead anodes hanging from the steel piping on the sides of the tank.

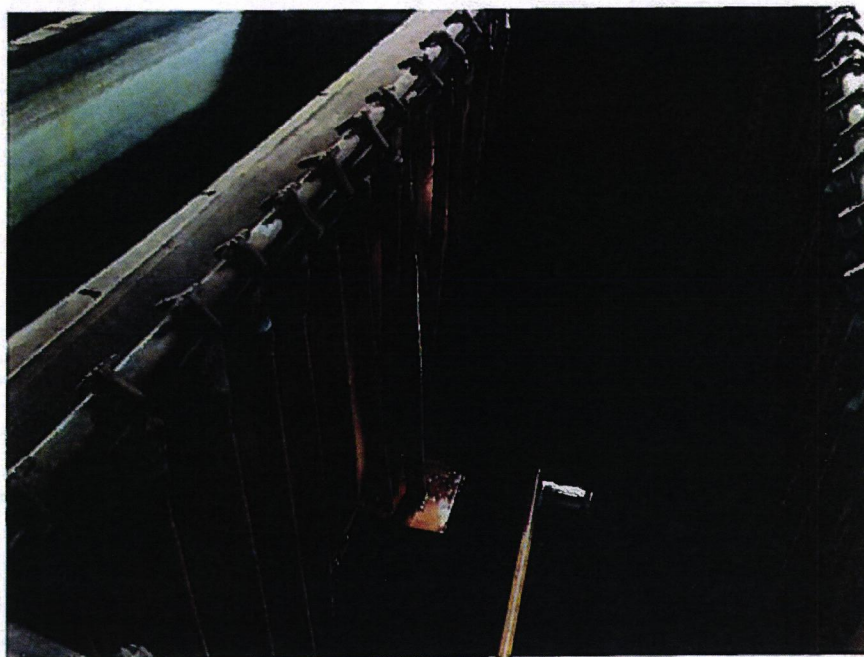
Photo 15 – 09/06/2016. Main plating line tank with lead anodes hanging from steel piping on the sides of the tank.

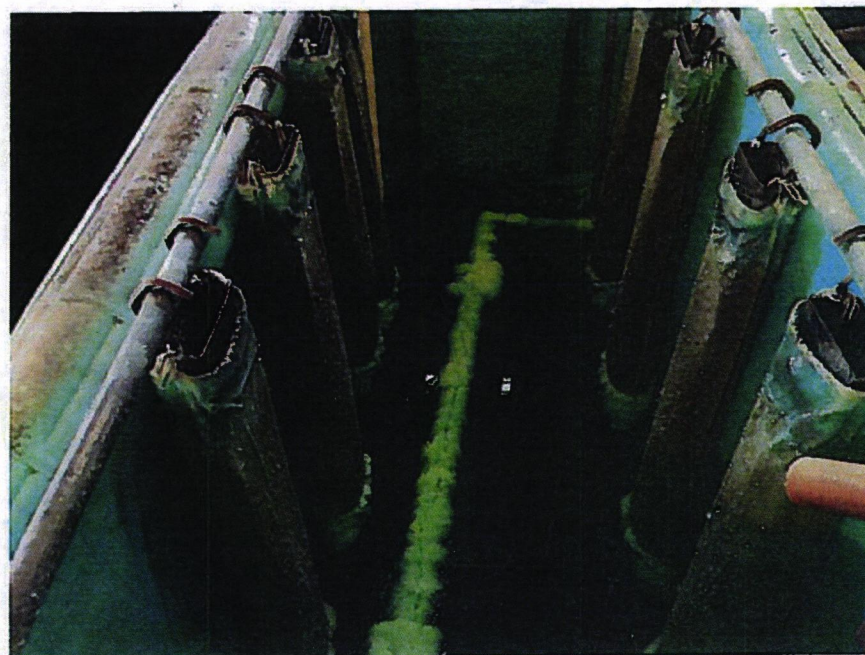
Photo 16 – 09/06/2016. Main plating line tank with lead anodes hanging from steel piping on the sides of the tank. Liquids remaining in the bottom of the tank.

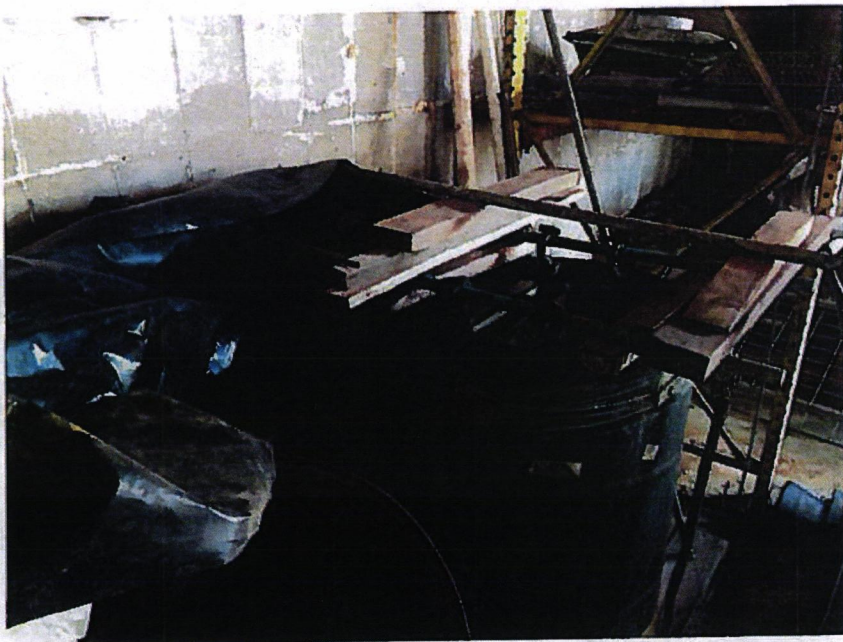
Photo 17 – 09/06/2016. Barrel line located north of the main plating line. Lead anodes hanging from steel pipes along the sides of the barrels.

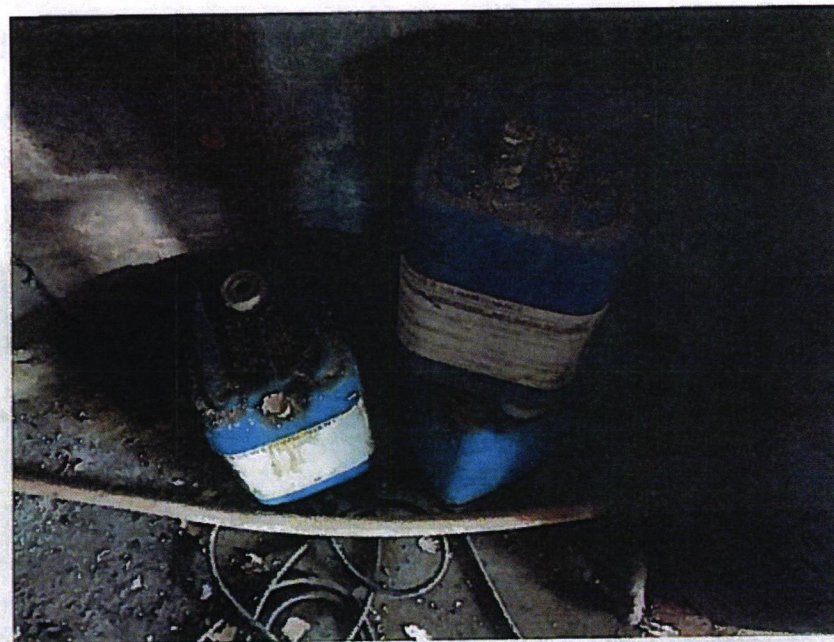
Photo 18 – 09/06/2016. Three five-gallon blue carboy containers observed next to the barrel line.

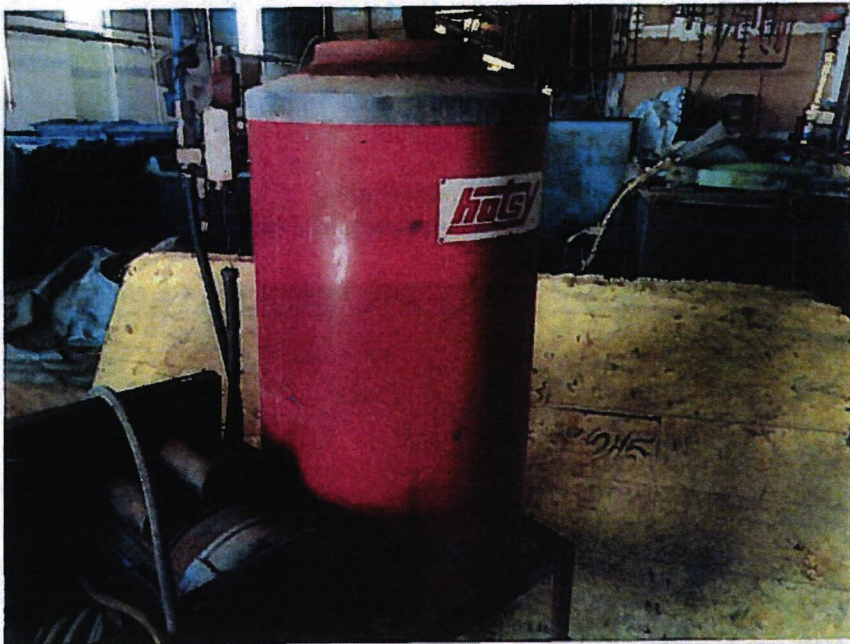
Photo 19 – 09/06/2016. Potential sludge and liquids in the 20-gallon "Hotsy" washer tank.

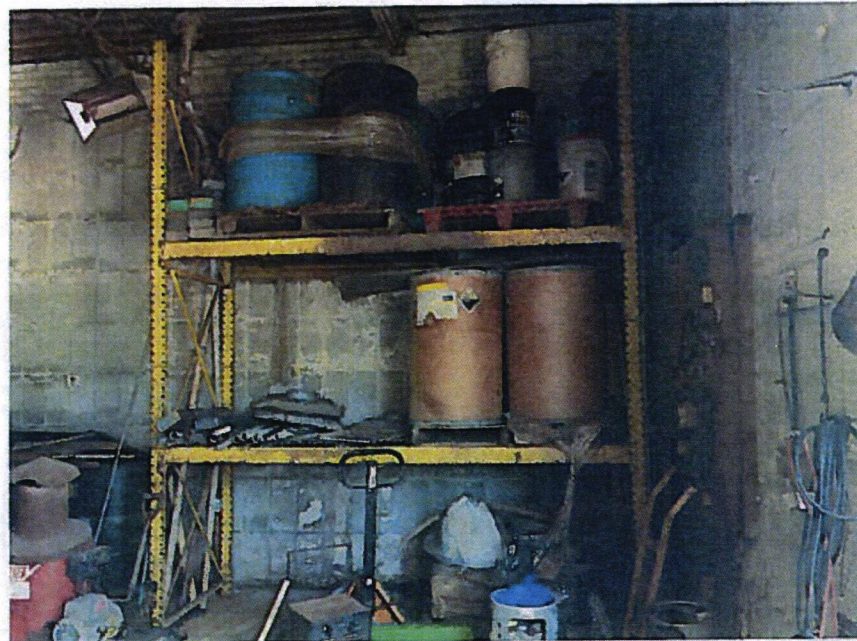
Photo 20 – 09/06/2016. Containers and other items stored on and beneath the North shelving unit.

inspection and were included on the 2016 NOV for failure to make a waste determination (photo 20 in attachment 7 and photo 6 in attachment 5). The six plastic containers appeared to contain oil lubricants and remain onsite. Their conditions appeared to be unchanged since the September 9, 2016, EPA inspection. I informed Ms. Atkinson that a waste determination must be performed for the bags and plastic containers to ensure proper disposal (attachment 9).

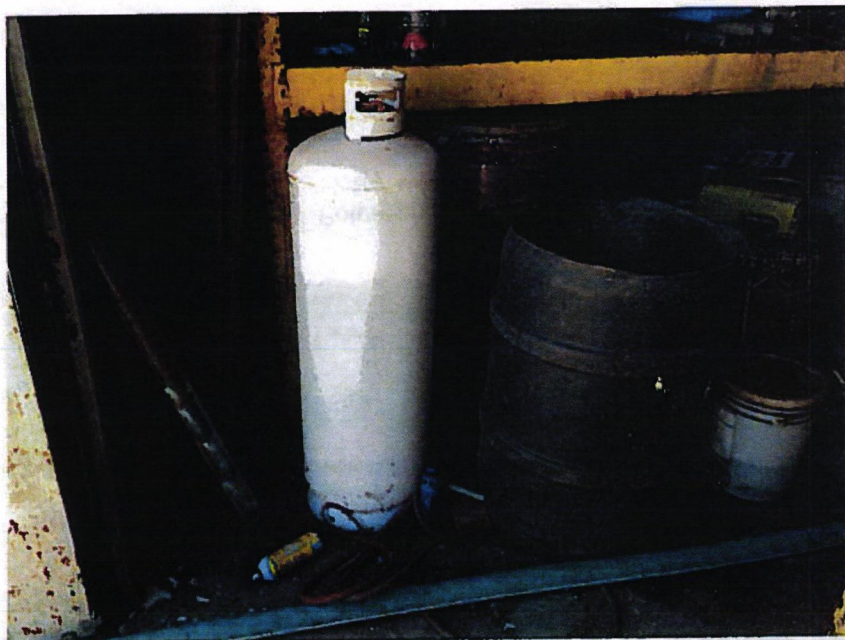
Photo 21 – 09/06/2016. Containers and other items stored beneath the South shelving unit.

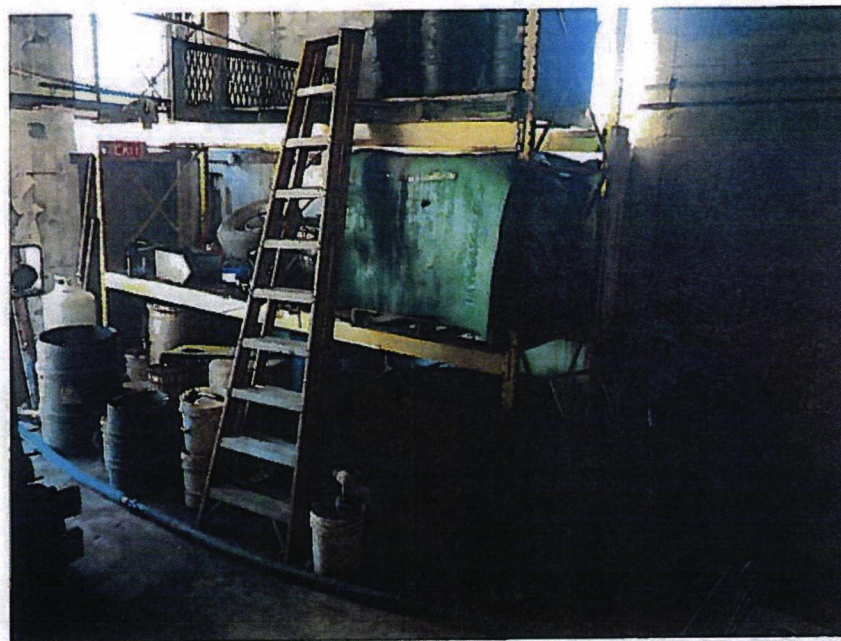
Photo 22 – 09/06/2016. Containers and other items stored on and beneath the South shelving unit.

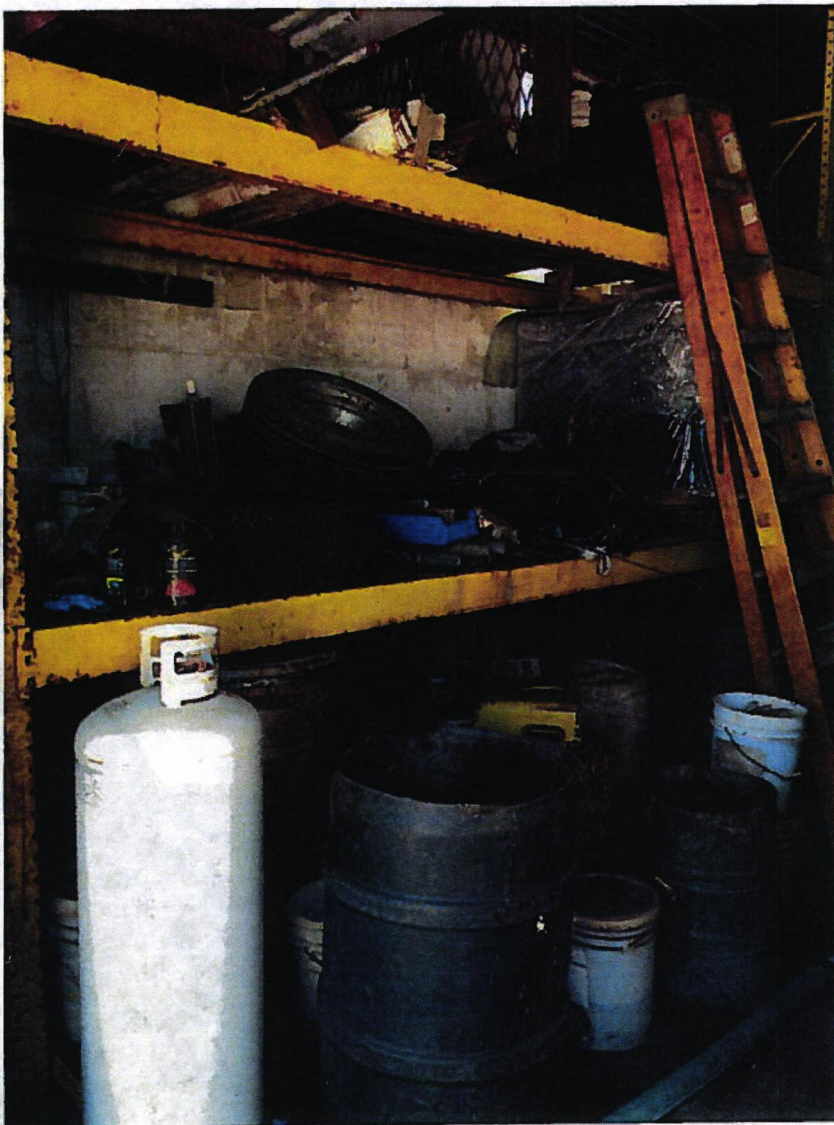
Photo 23 – 09/06/2016. Containers and other items stored on and beneath the South shelving unit.

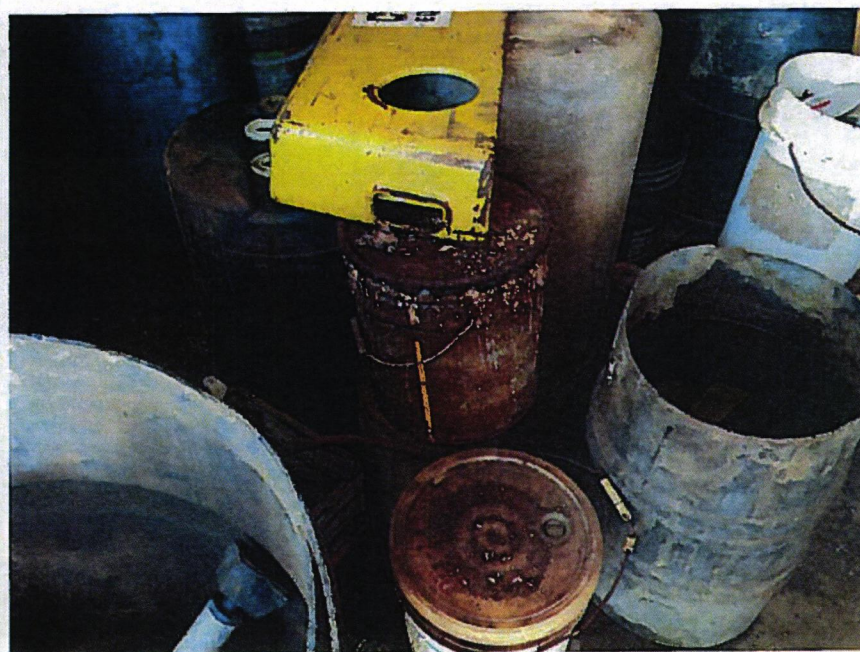
Photo 24 – 09/06/2016. Containers and other items stored beneath the South shelving unit.

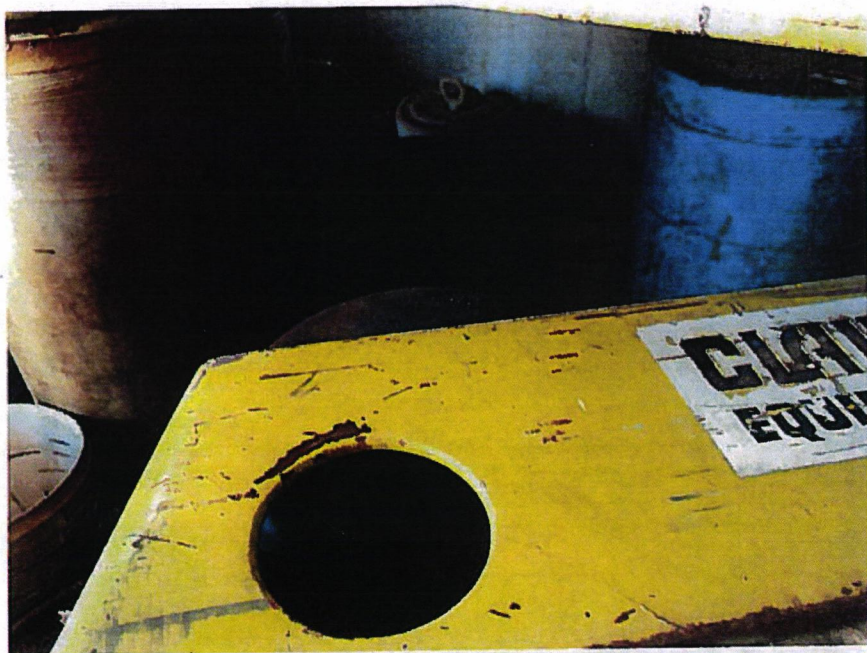
Photo 25 – 09/06/2016. Containers and other items stored beneath the South shelving unit.

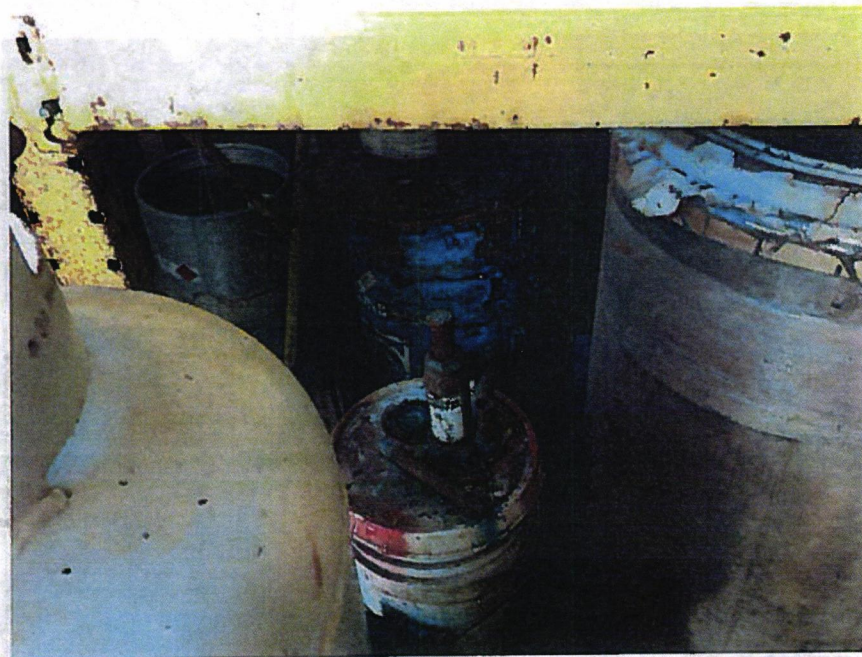
Photo 26 – 09/06/2016. Containers and other items stored beneath the South shelving unit.

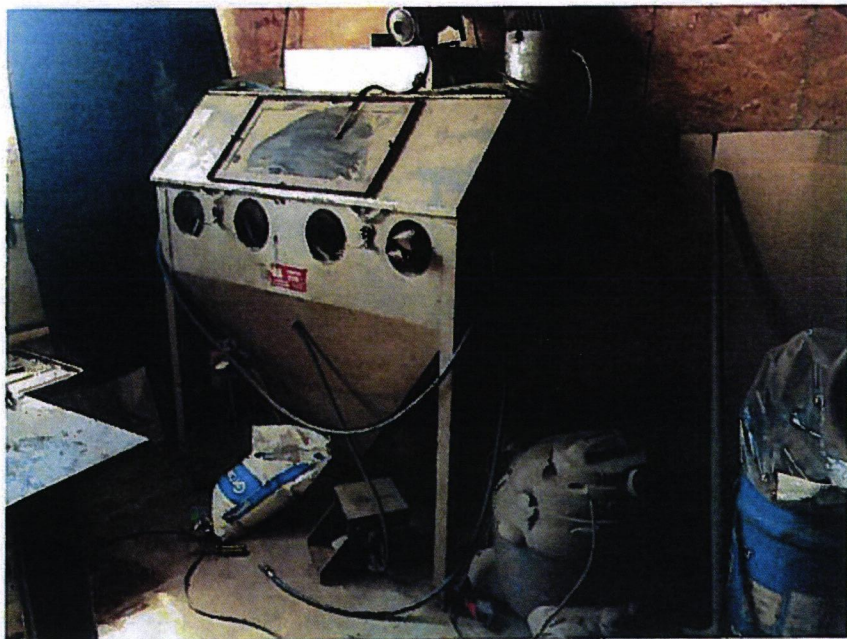
Photo 27 – 09/06/2016. Sand blasting unit and wet/dry vacuum located inside of the metal finishing room, west side of the building.

Sand Blaster Media in Metal Finishing Area – I observed the sand blasting unit that was identified during the September 9, 2016, EPA inspection and was included on the 2016 NOV for failure to make a waste determination for the waste sand blasting media that remained inside the sand blasting unit (photo 27 in attachment 7). The sand blasting media remained in the sand blasting unit and the conditions appeared to be unchanged since the September 9, 2016, EPA inspection. I informed Ms. Atkinson that a waste determination must be performed to ensure proper disposal (attachment 9).

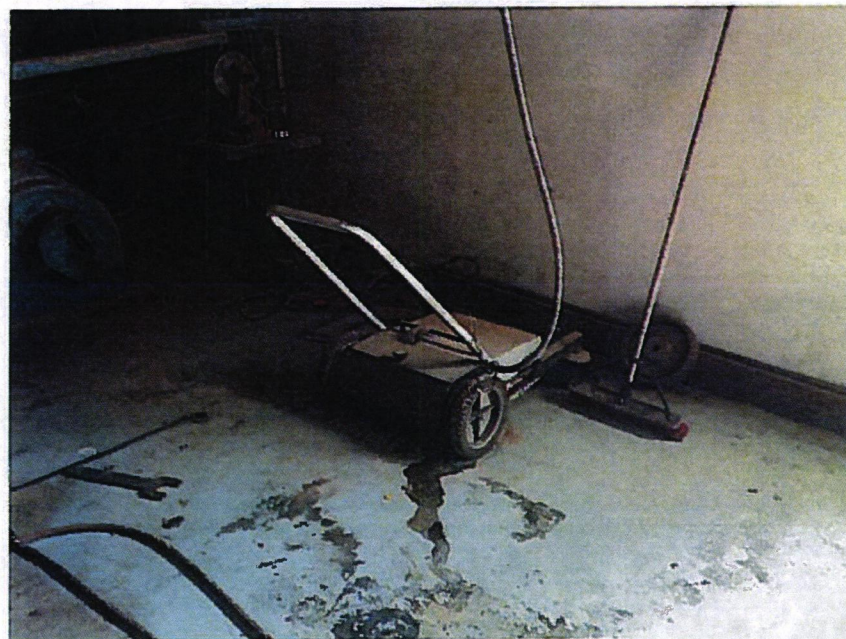
Photo 28 – 09/06/2016. Floor sweeper unit inside of the metal finishing room, west side of the building.

Dust in Wet/Dry Vacuum and Floor Sweeping Unit in Metal Finishing Area – I observed the wet dry vacuum and floor sweeping unit that were identified during the September 9, 2016, EPA inspection and were included on the 2016, NOV for failure to make a waste determination of the dust that remained inside them (photos 27 & 28 in attachment 7). There was also a vacuum cleaner located north of the metal finishing area in the maintenance/metal finishing area (photo 29 in attachment 7). The dust remained in the wet/dry vacuum, vacuum cleaner, and floor sweeping unit and the conditions appeared to be unchanged since the September 9, 2016, EPA inspection. I informed Ms. Atkinson that a waste determination must be performed to ensure proper disposal (attachment 9).

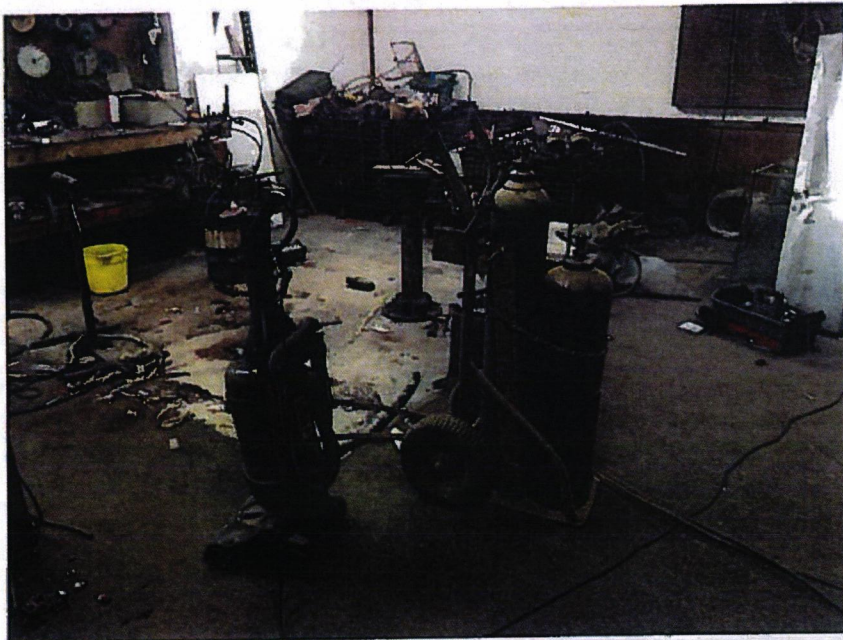
Photo 29 – 09/06/2016. Vacuum cleaner unit and gas cylinders observed in the metal finishing area.

Multiple Gas Cylinders – I observed several gas cylinders located throughout the facility that were identified during the September 9, 2016, EPA inspection and were included on the 2016, NOV for failure to make a waste determination if they could not be used as originally intended (photos 27 & 28 in attachment 7). The gas cylinders remained in the plating area and in the maintenance/metal finishing area and the conditions appeared to be unchanged since the September 9, 2016, EPA inspection. I informed Ms. Atkinson that a waste determination must be performed if they could not be used as originally intended to ensure proper disposal (attachment 9). Ms. Atkinson stated she was sure the gas cylinders could still be used as products and were not wastes.

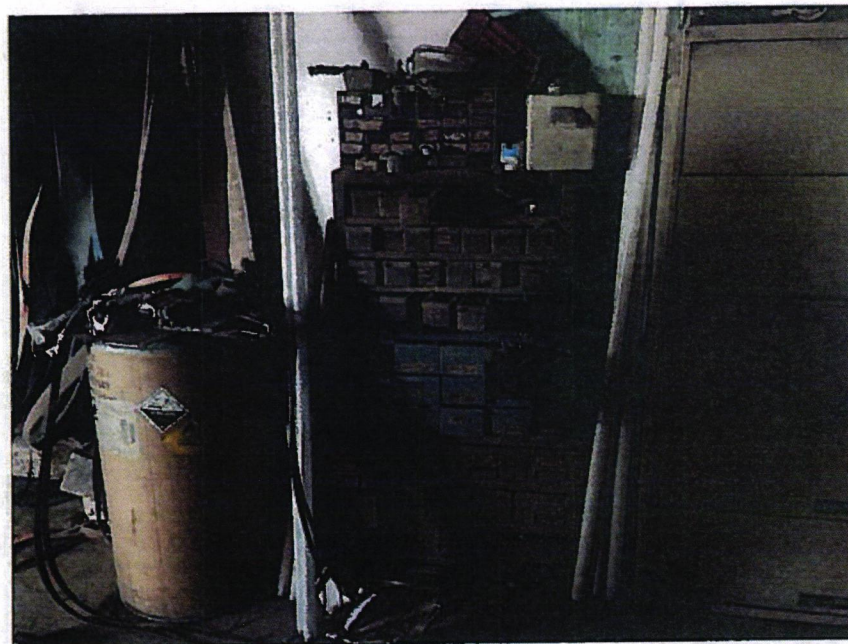
Photo 30 – 09/06/2016. Spent fluorescent lamps observed in the metal finishing area.

Spent Fluorescent Lamps – I observed spent fluorescent lamps in the plating area and metal finishing area that were identified during the September 9, 2016, EPA inspection and were included on the 2016, NOV for failure to make a waste determination (photos 2 & 30 in attachment 7). The spent fluorescent lamps remain onsite and the conditions appeared to be unchanged since the September 9, 2016, EPA inspection. I informed Ms. Atkinson that a waste
